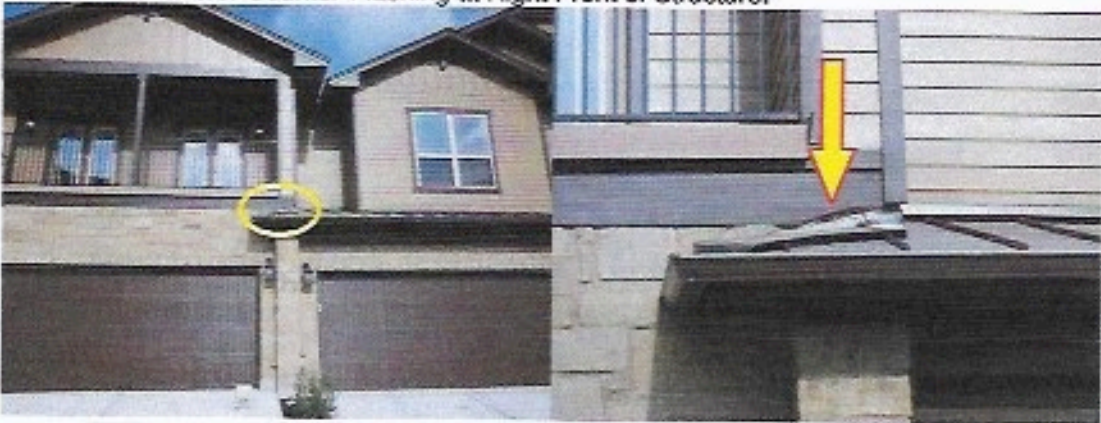
(1 x 12) Horizontal Trim was not installed in a professional manner at time of inspection at juncture of Rock Veneer and/or Counter-Flashing at Right Front of Structure.
