Driver's Side Window Finish

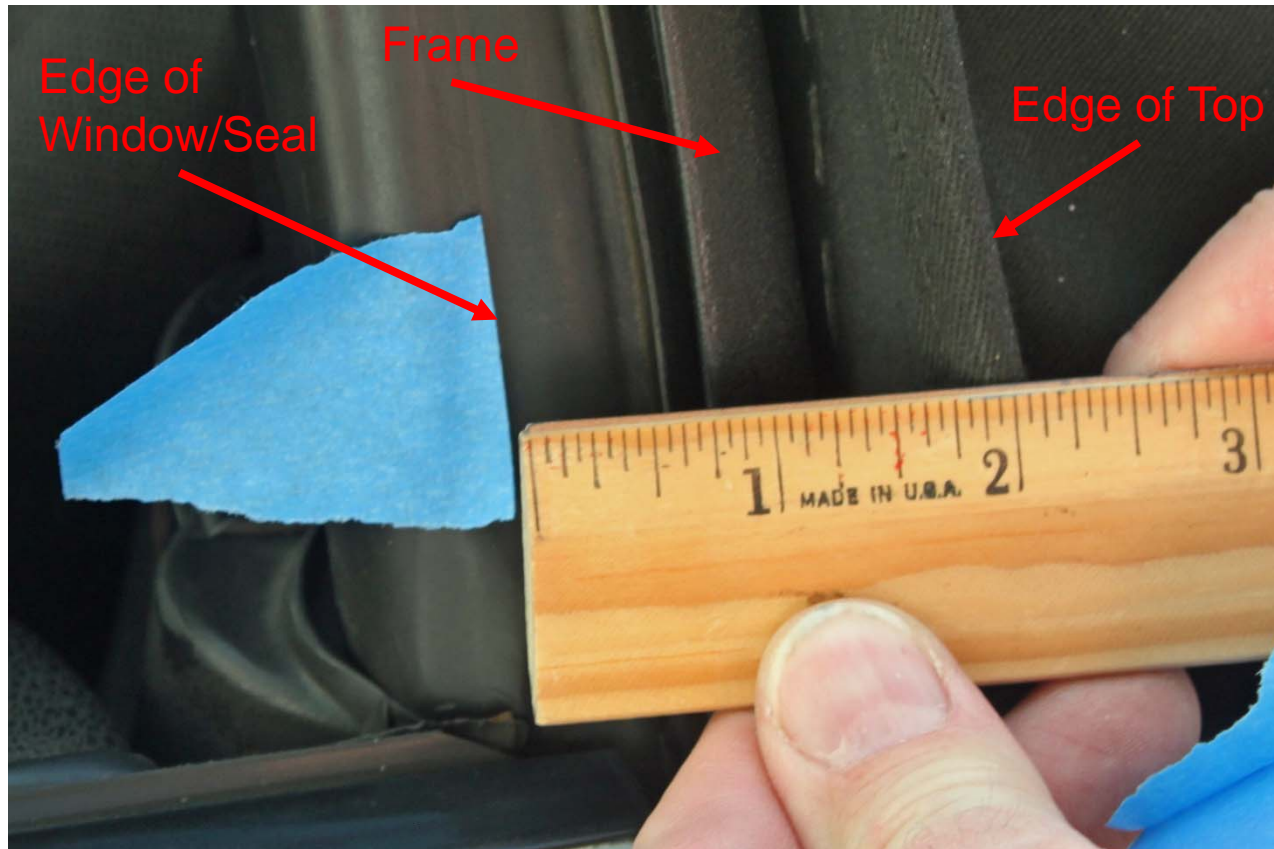
Fabric of top is almost two inches too short. This causes water Intrusion. Top should cover the frame and overlap window/seal.
