HAIGHT DAVIS & ASSOCIATES, INC.

May 19, 2016

Re: Evaluation of Structural Issues at 130 Galesburg Drive, Lawrenceville, Georgia
Project No. LS-16-114

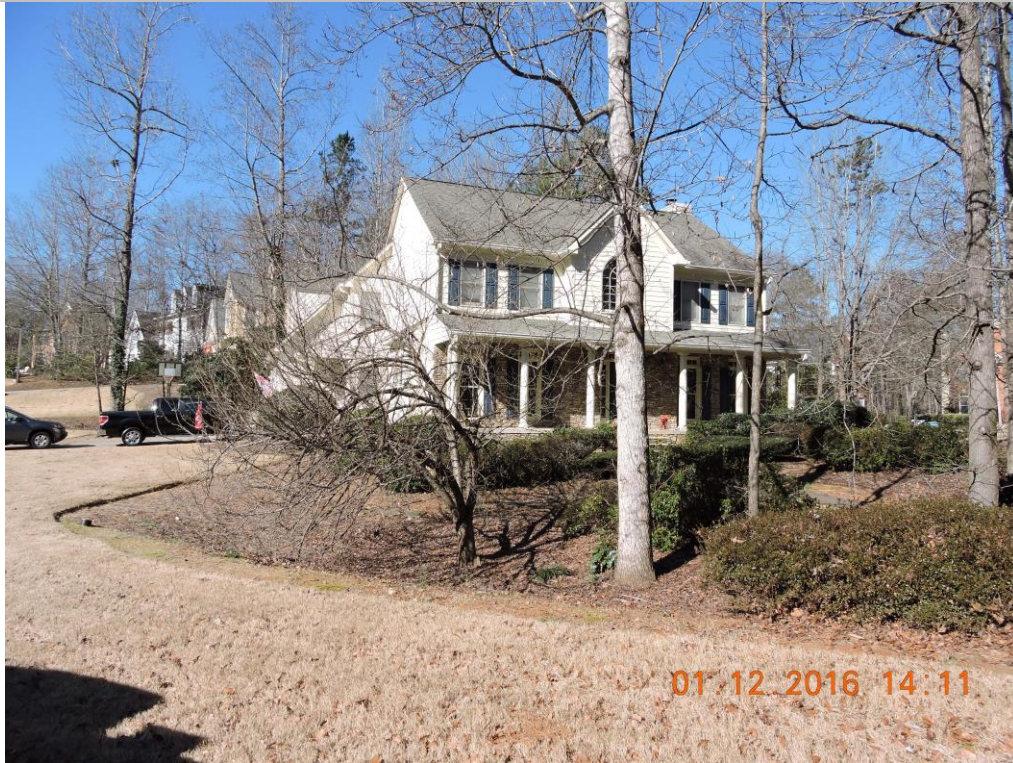
PHOTO 1

The home located at 130 Galesburg Drive in Lawrenceville, Georgia is a two-story, wood-framed structure, veneered with brick and siding (*Photos 1 and 2*). There is a side facing two-car garage along the left* side of the home. The structure is constructed with a crawlspace foundation and the lot is sloped gently from right to left and from rear to front.

Williams Residence, 130 Galesburg Drive, Lawrenceville, GA

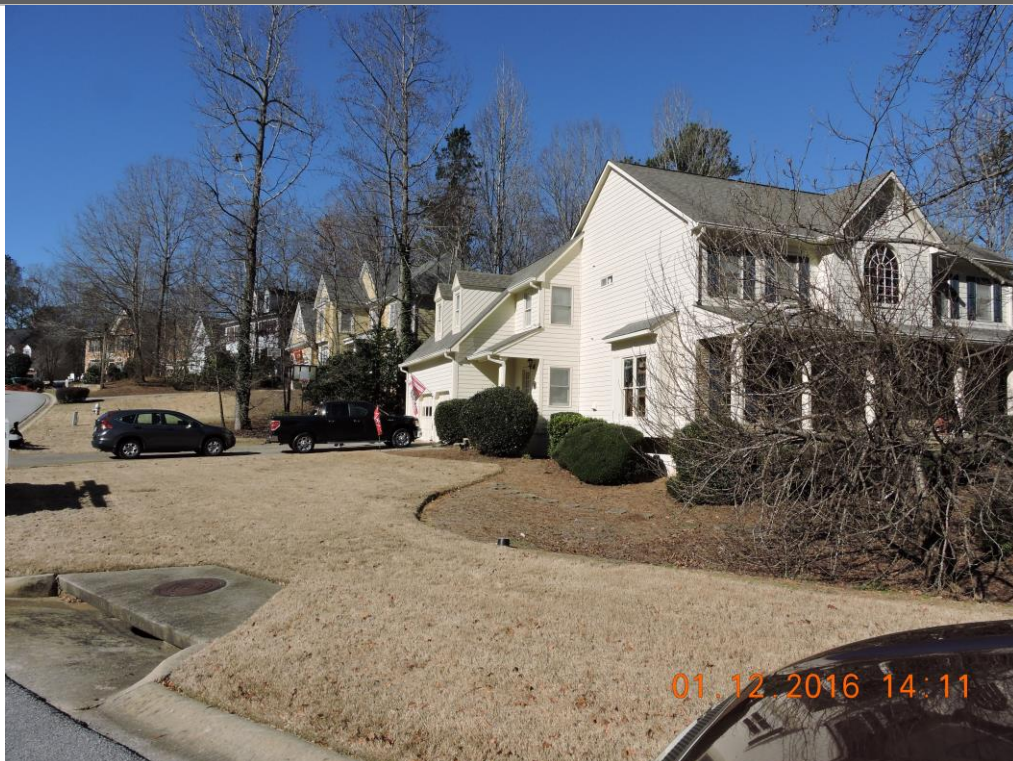
PHOTO 2

Williams Residence, 130 Galesburg Drive, Lawrenceville, GA

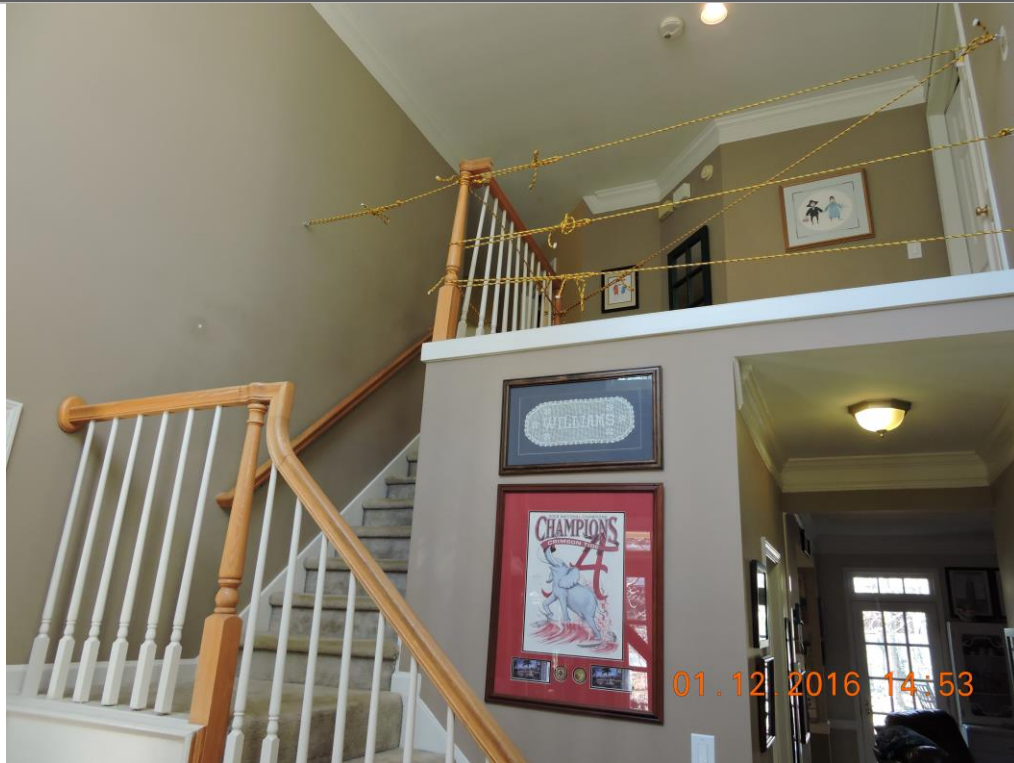
PHOTO 3

The area where the guardrail originally was in place was blocked off with yellow caution tape to visually warn those in the near proximity that the railing was no longer in place (*Photos 3, 4, 5 and 6*). However, nothing else had been touched or repaired. The drywall surface where the rail detached was still intact (*Photos 7, 8 and 9*).

Yellow caution tape is in place at the area where the railing failed.

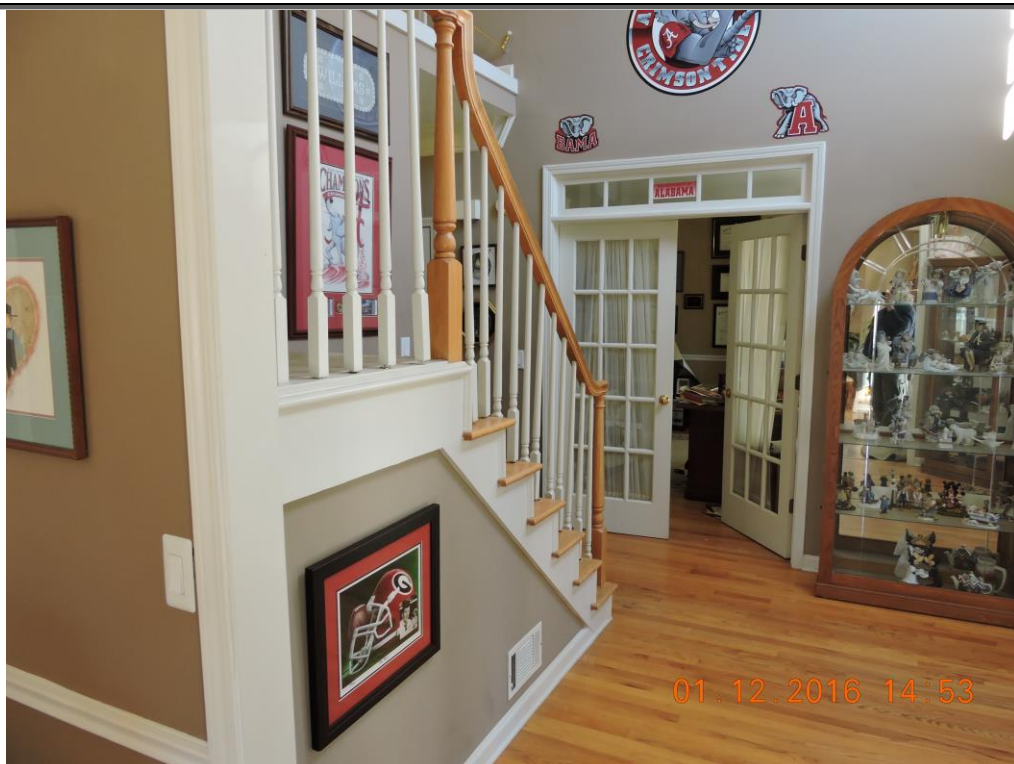
PHOTO 4

Yellow caution tape is in place at the area where the railing failed.

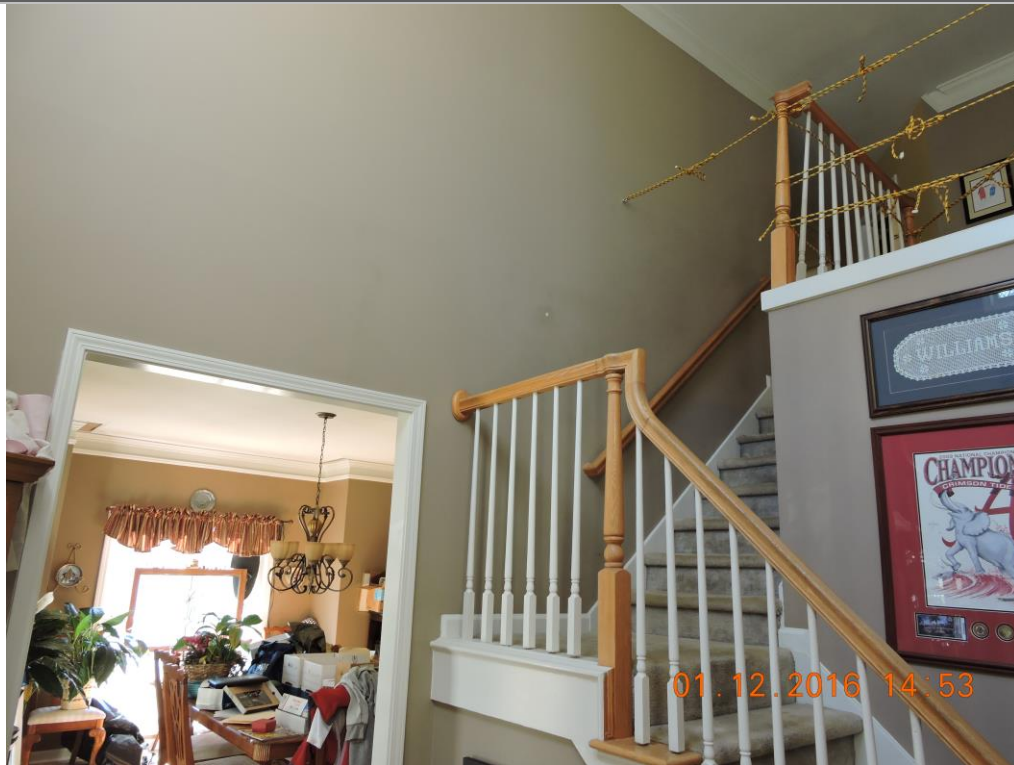
PHOTO 5

Yellow caution tape is in place at the area where the railing failed.

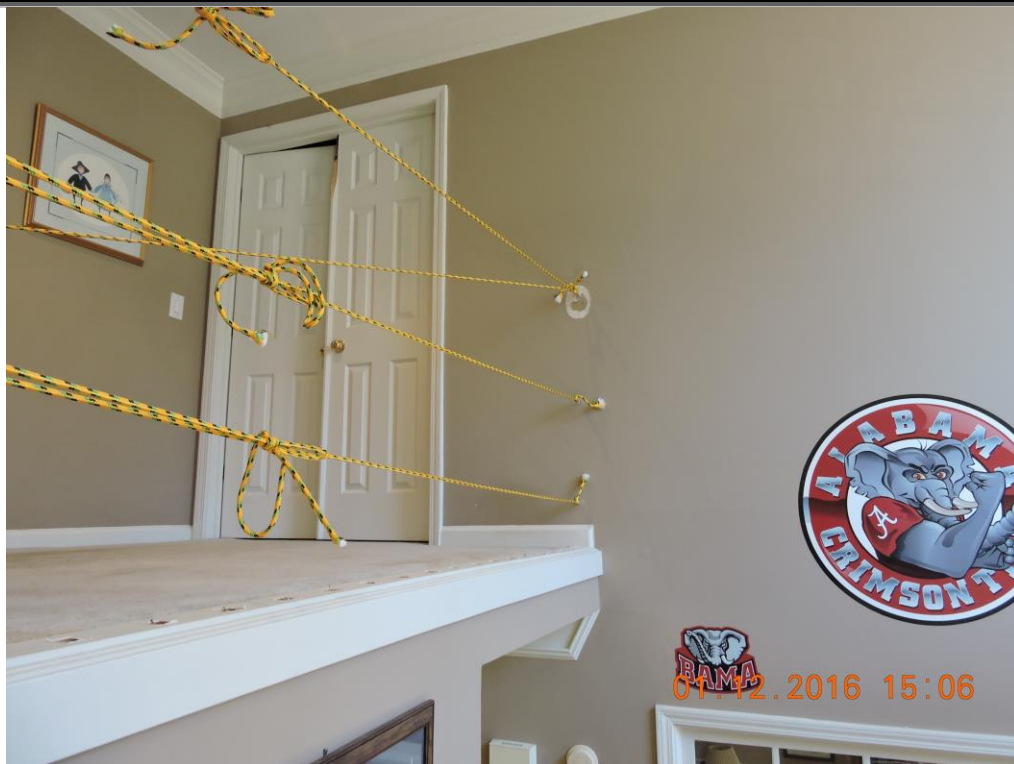
PHOTO 6

Yellow caution tape is in place at the area where the railing failed.

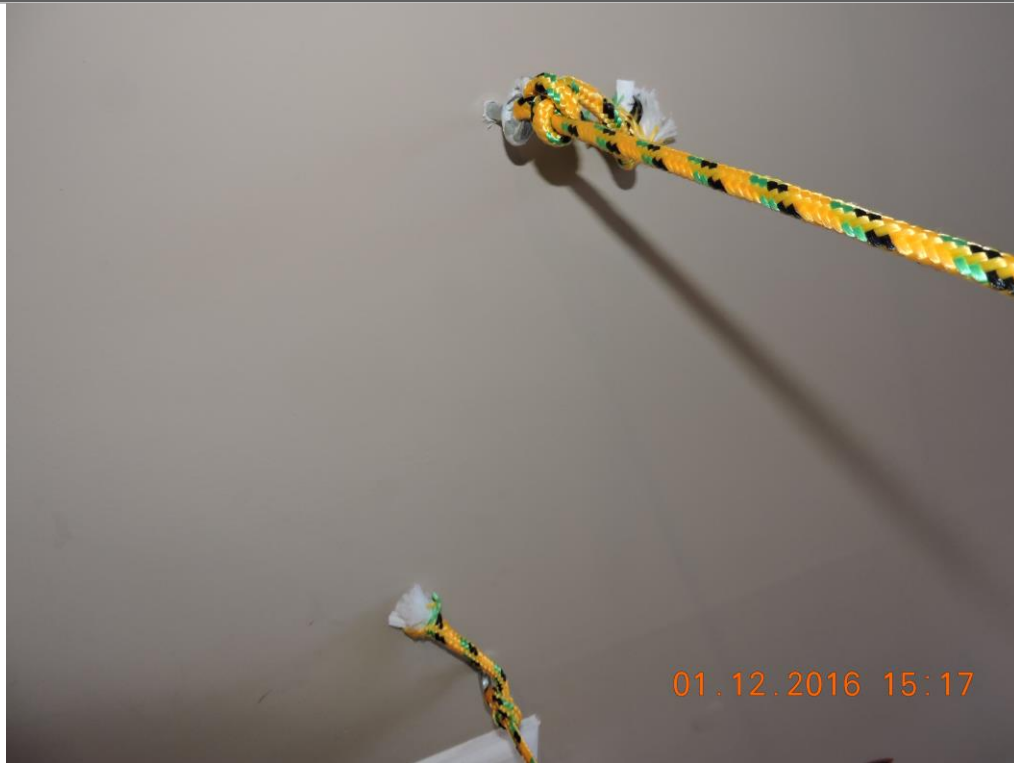
PHOTO 7

The drywall surface is still intact.

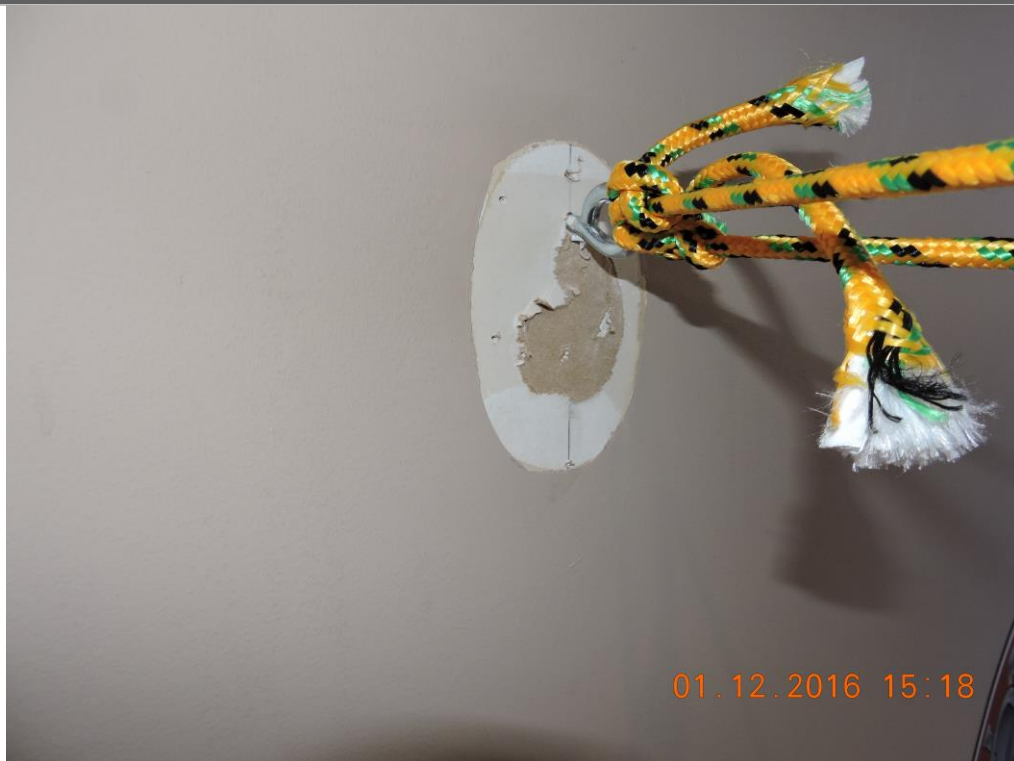
PHOTO 8

The drywall surface is still intact.

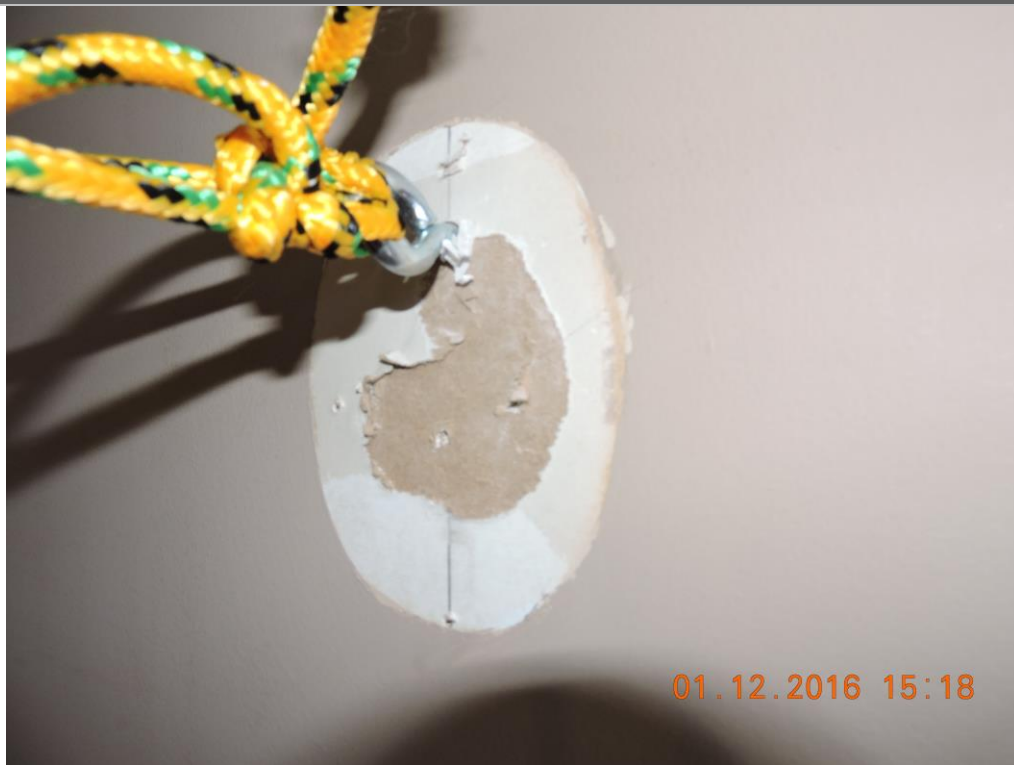
PHOTO 9

The drywall surface is still intact.

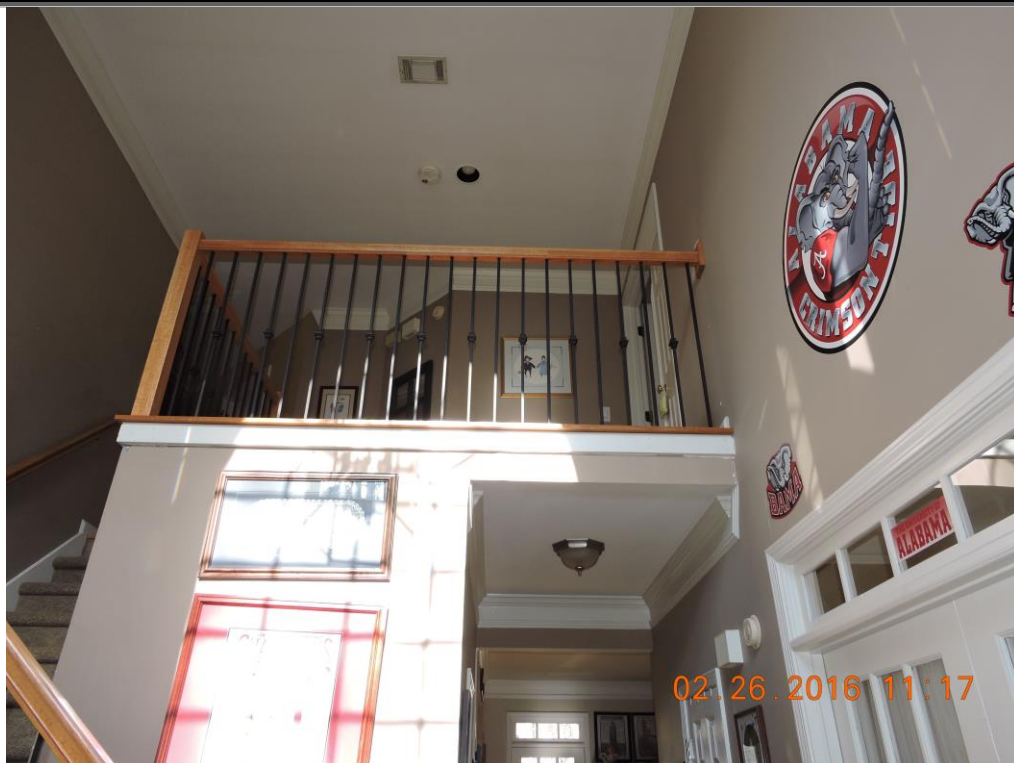
PHOTO 10

The guardrail has been replaced.

- B. **Second Site Visit – February 29, 2016.** Repairs to the guardrail were completed in the months of January and February. When we arrived to re-evaluate the condition of the site, the entire guardrail along the second floor landing and along the stairs had been fully replaced (*Photos 10, 11 and 12*).

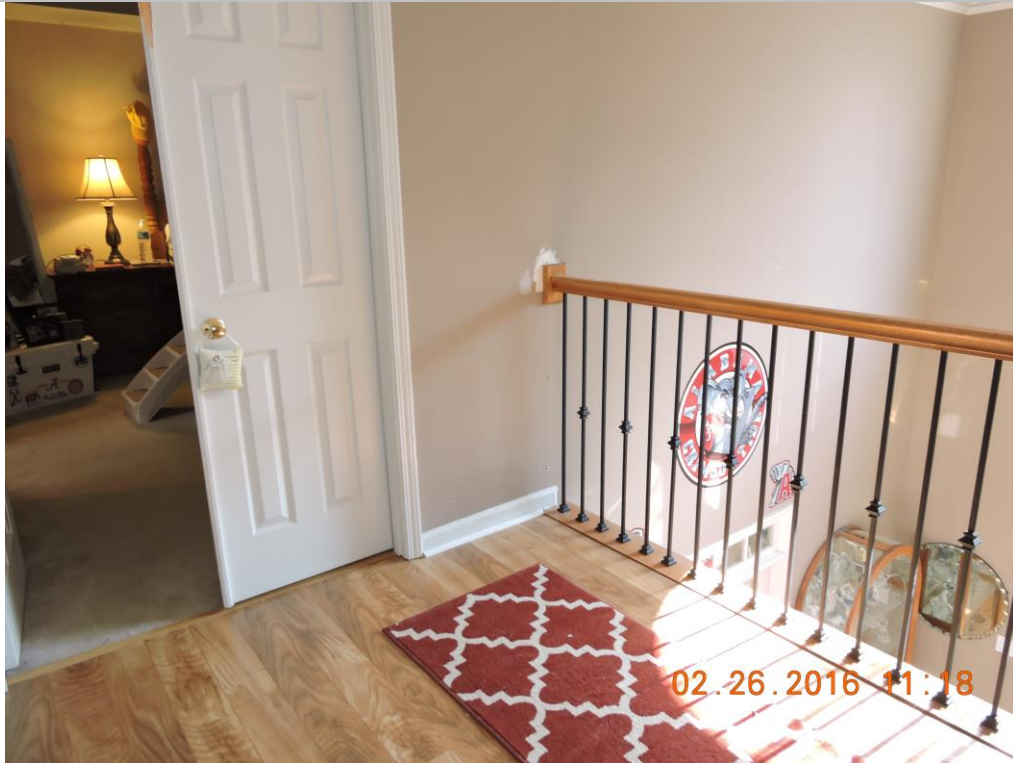
PHOTO 11

The guardrail has been replaced.

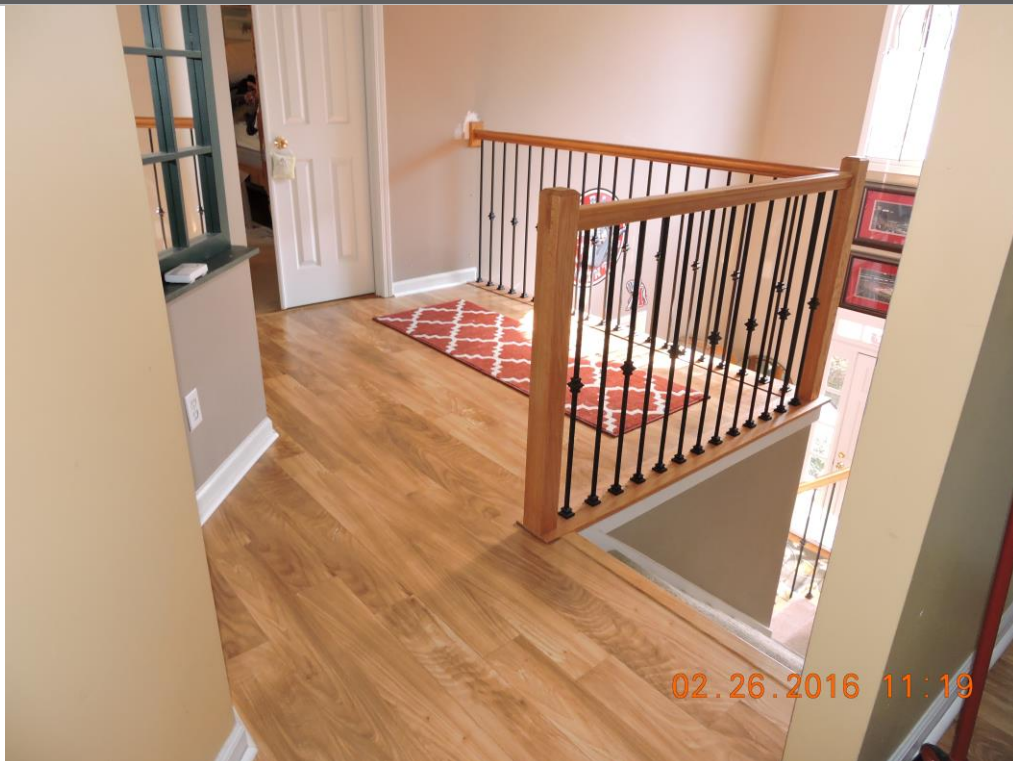
PHOTO 12

The guardrail has been replaced.

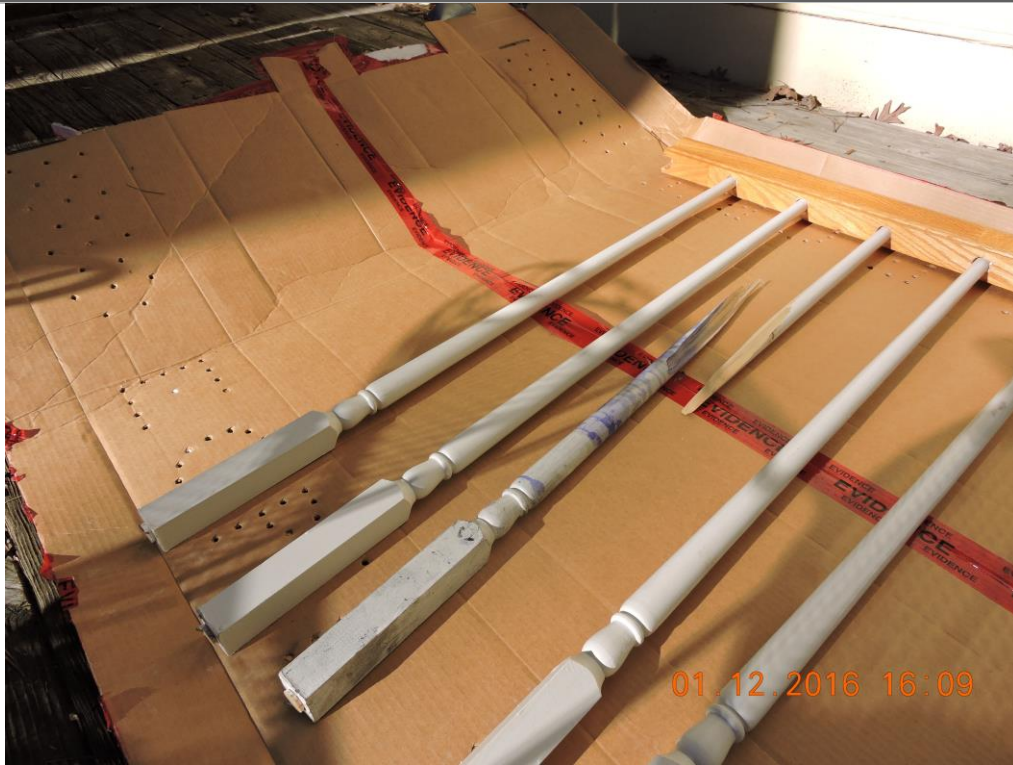
PHOTO 13

- C. **Guardrail Assessment.** The failed section of guardrail measured 8 feet long and 41 inches in height (*Photo 13*). The balusters were constructed of painted wood with an appropriate railing along the top.

The failed section of guardrail.

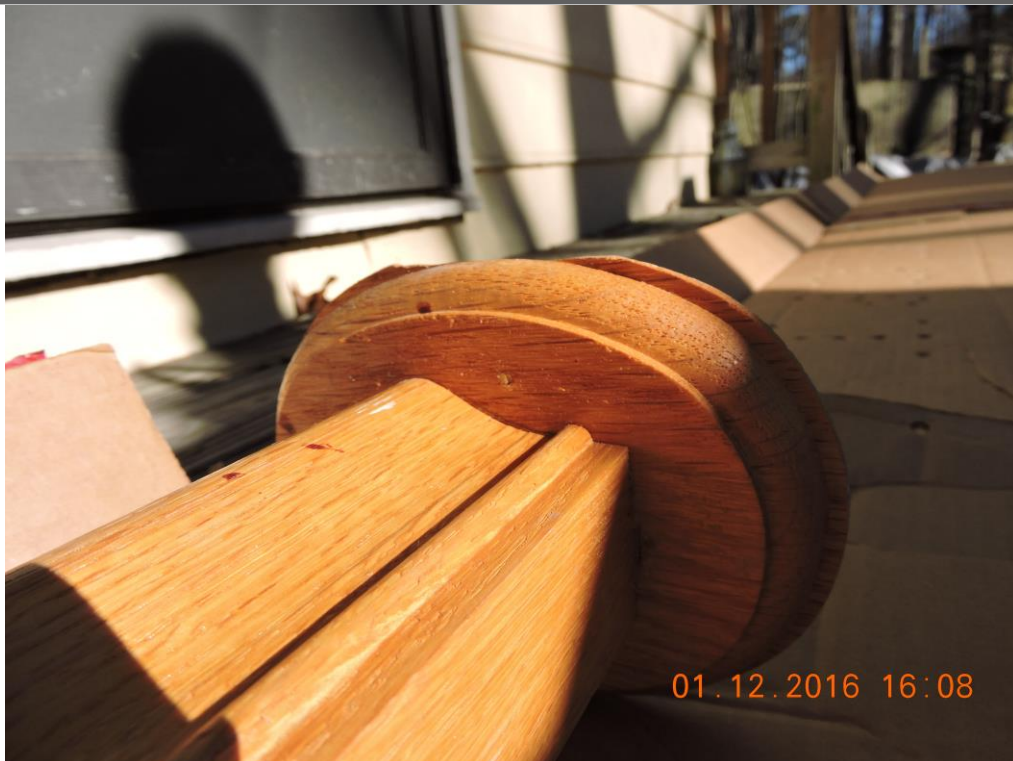
PHOTO 14

On the right side, the guardrail was attached to the drywall surface with a wood rosette (*Photos 14 and 15*). Along the left side, the guardrail was connected to a newel post. The top railing was jointed at the newel location with a 90-degree angle piece providing a change in direction of the railing (*Photos 16 and 17*). The continuation of the guardrail provided a barrier between the second floor foyer and the descending stairs (*Photo 18*).

The guardrail was attached to the drywall surface with a wood rosette.

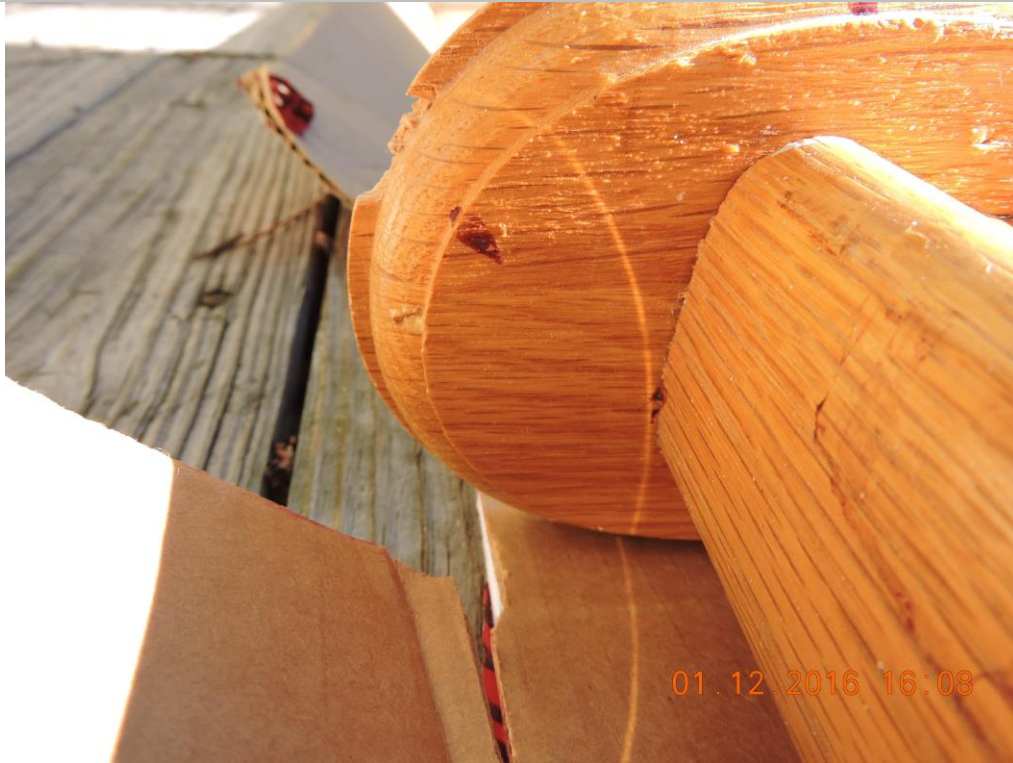
PHOTO 15

The guardrail was attached to the drywall surface with a wood rosette.

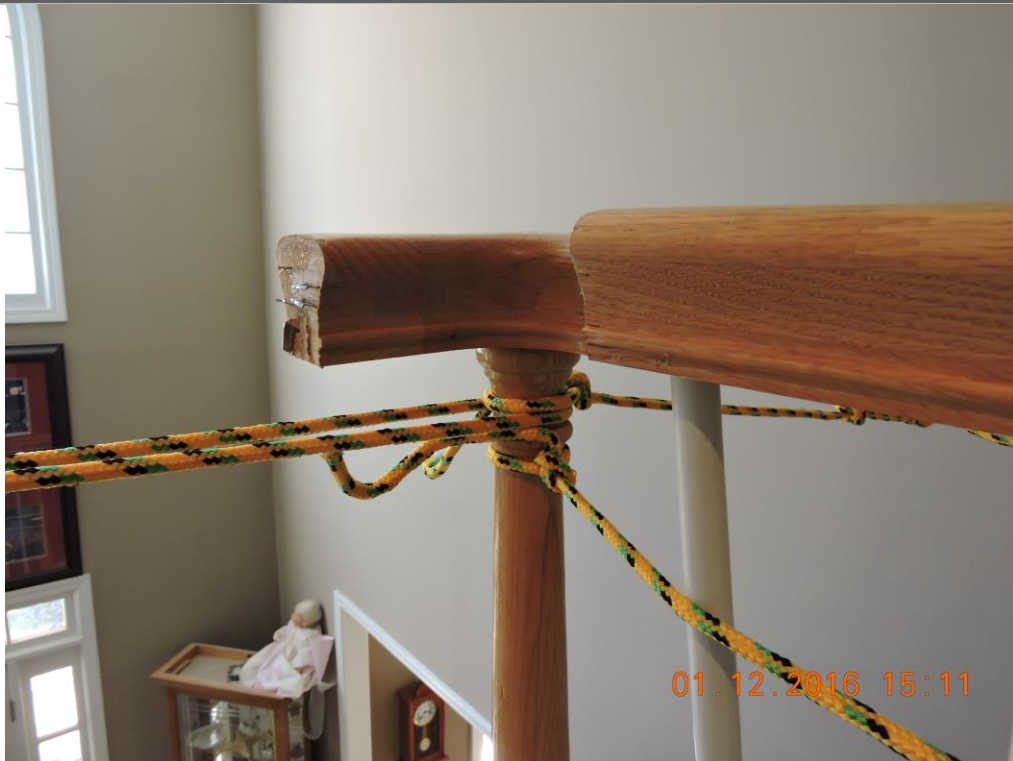
PHOTO 16

A 90 degree angle piece provided a change in direction of the railing.

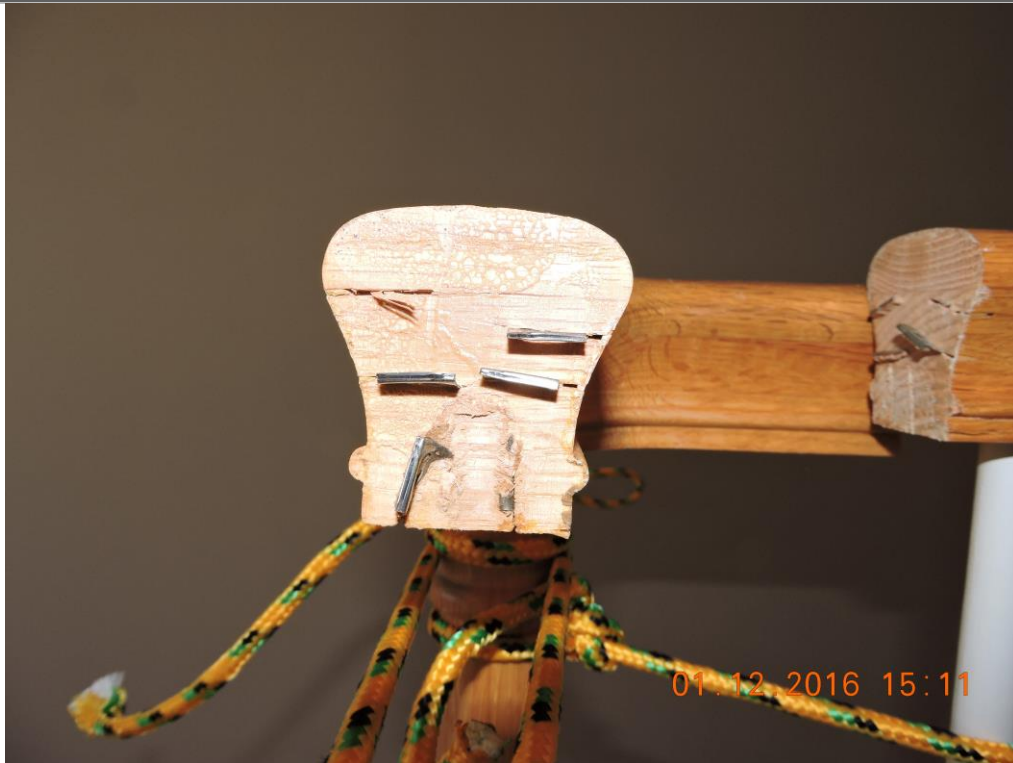
PHOTO 17

A 90 degree angle piece provided a change in direction of the railing.

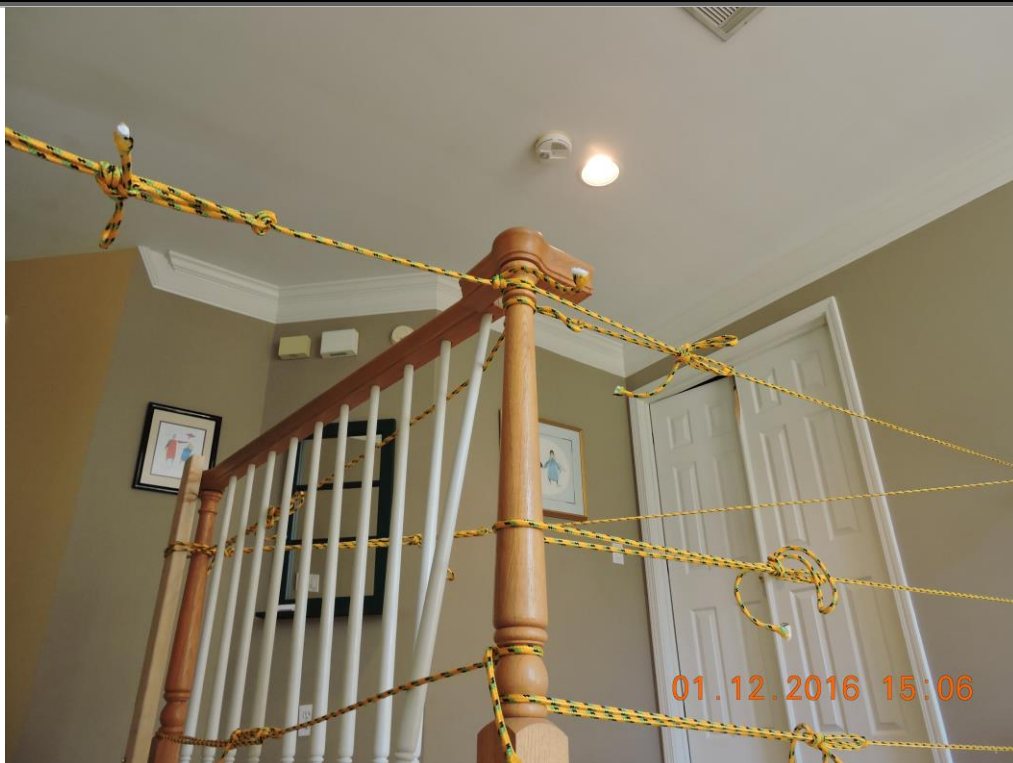
PHOTO 18

The continuation of the guardrail was a barrier along the stairs.

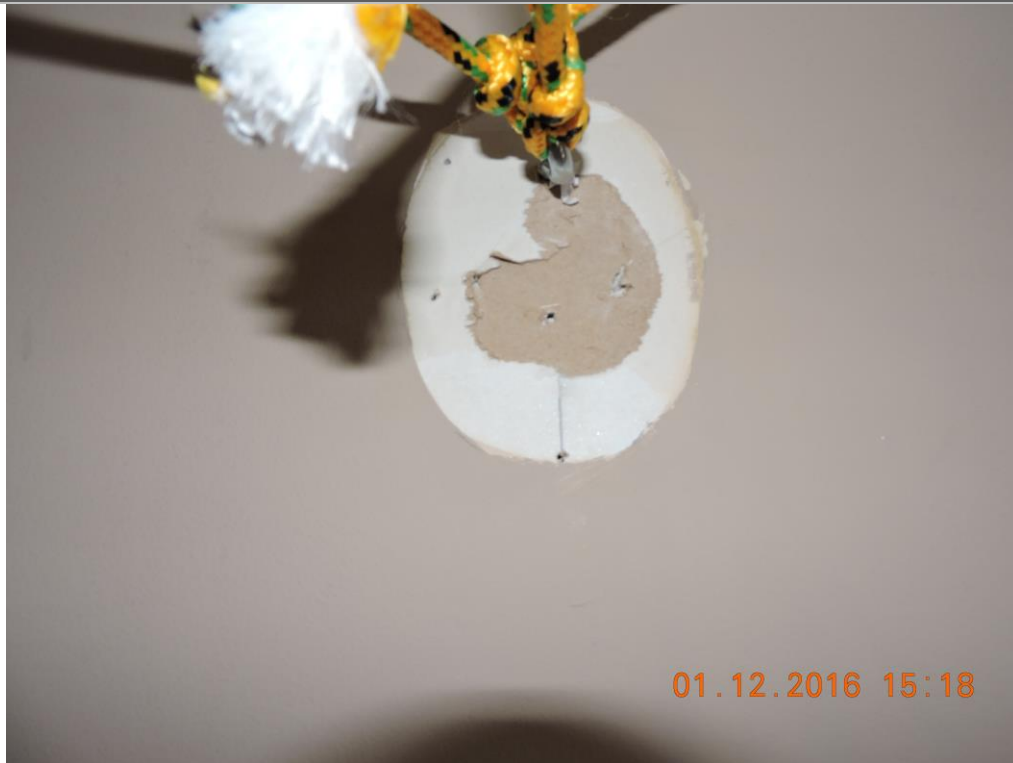
PHOTO 19

The guardrail failed at both of these ends. The rail came completely detached from the drywall surface without causing any significant damage to the drywall. The exposed area under the rosette indicated that only a small amount of glue was used to hold the rosette in place (*Photos 19 and 20*). Additionally, three 2-inch finish nails were used to attach the rosette to the drywall (*Photo 21*). The attachment, however, did not extend properly into the structural framing of the wall cavity. This lack of proper attachment allowed the railing to easily pull out of the wall.

A small amount of glue was used to hold the rosette in place.

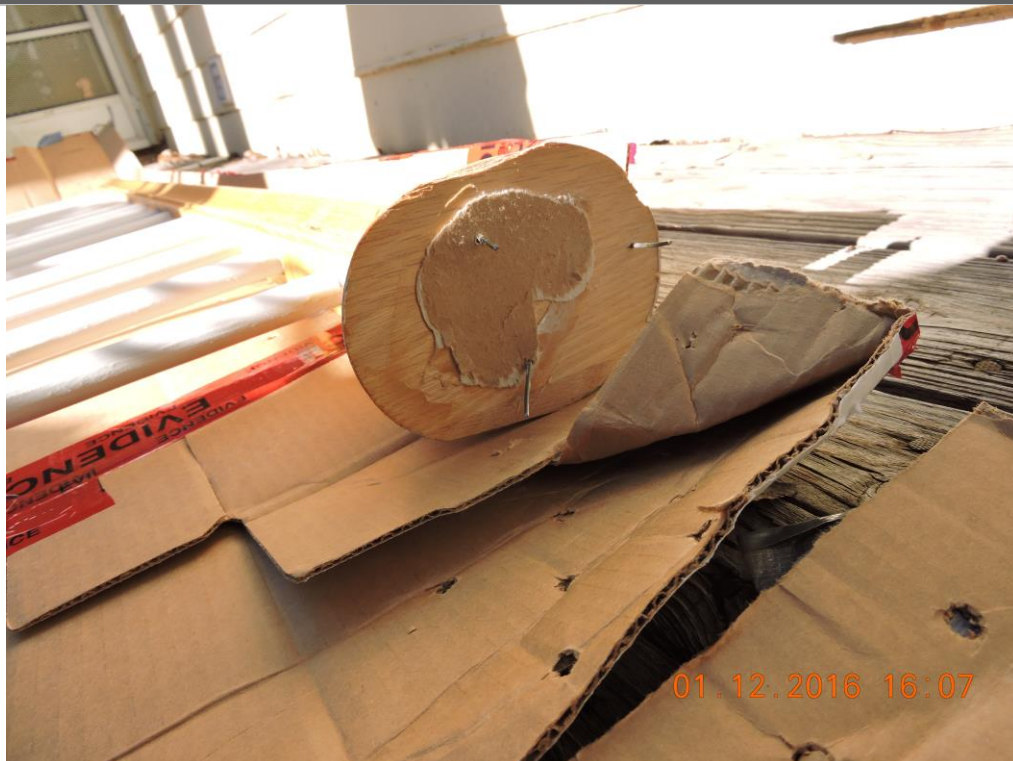
PHOTO 20

A small amount of glue was used to hold the rosette in place.

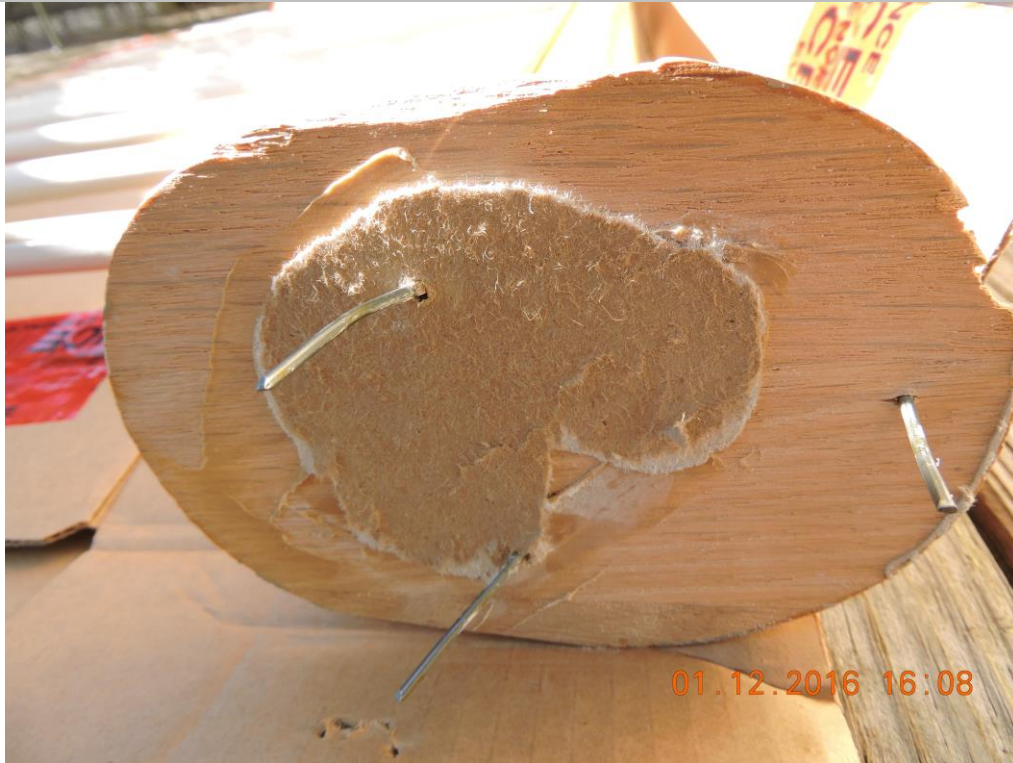
PHOTO 21

Finish nails were used to attach the rosette.

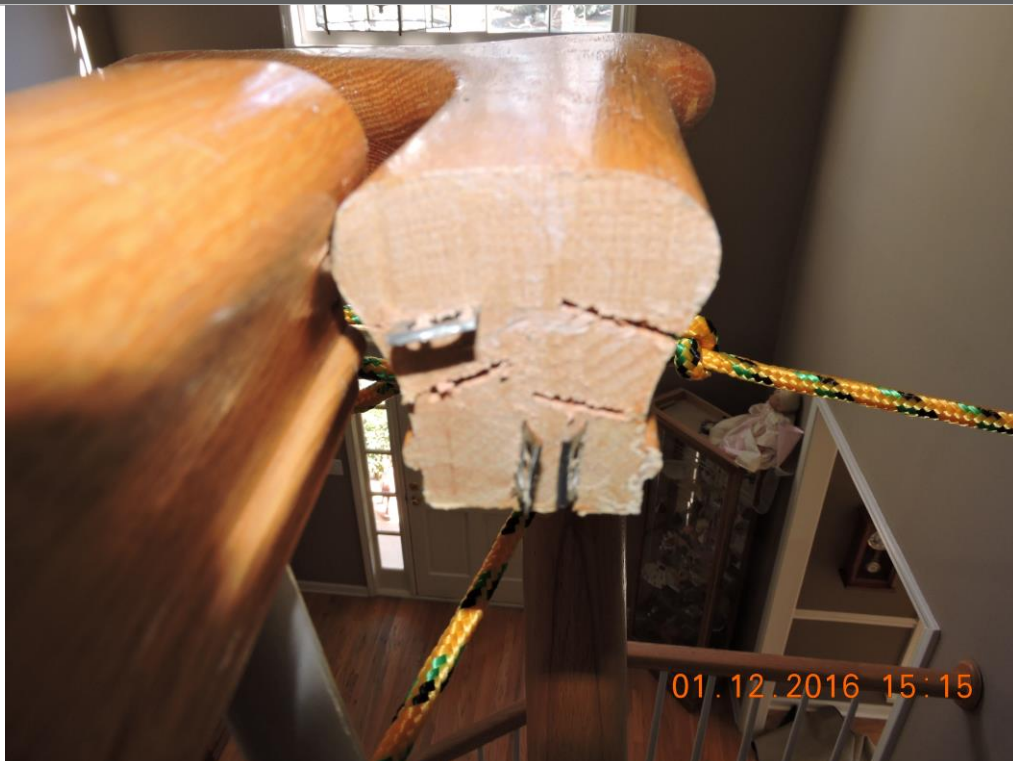
PHOTO 22

At the newel post, the top railing completely separated from the 90-degree angled section of railing. Six metal cleats were used to attach the two pieces of wood railing (*Photo 22*). Some of these metal cleats remained in place while others detached with the top railing (*Photo 23*).

Metal cleats were used to attach the two pieces of wood railing.

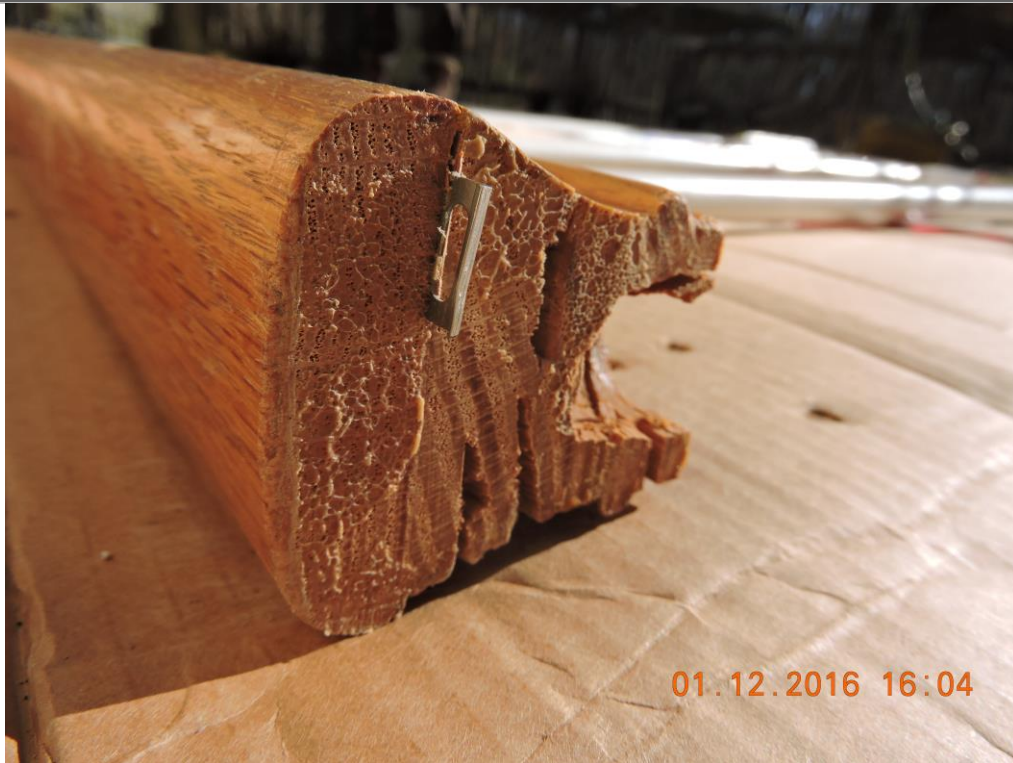
PHOTO 23

Metal cleats were used to attach the two pieces of wood railing.

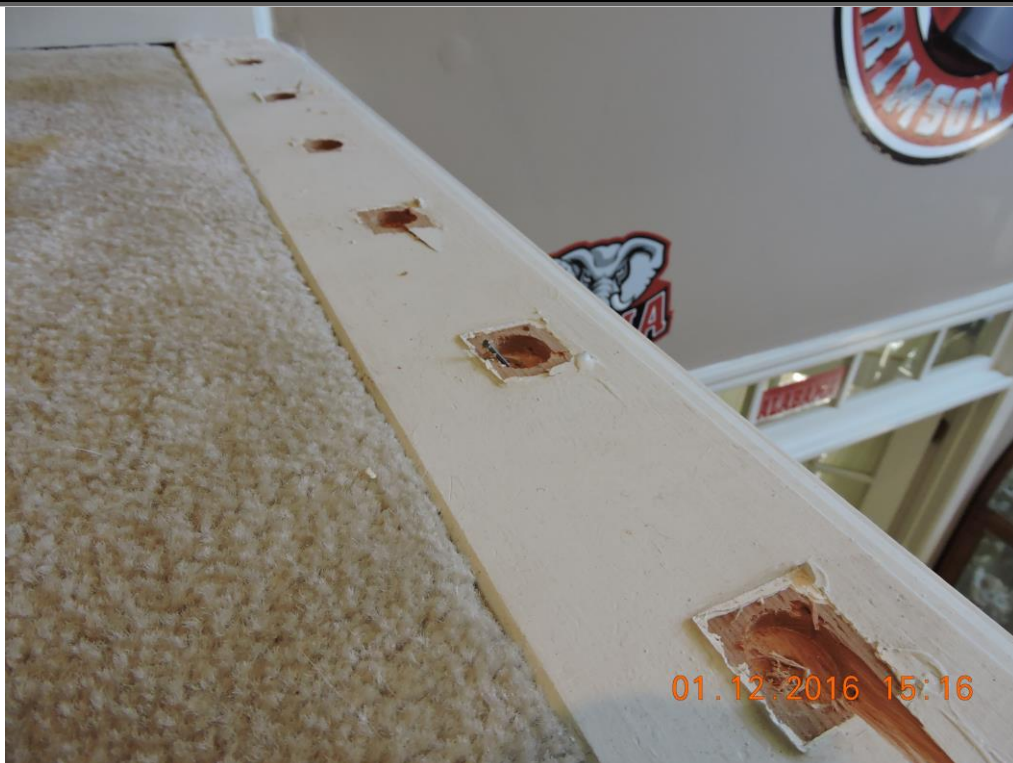
PHOTO 24

Each individual baluster completely detached at the base of the guardrail as well (*Photos 24, 25 and 26*). The horizontal baseplate, however, remained intact and in place. In some areas, small finish nails stayed fixed in the baseplate (*Photo 27*).

Each individual baluster completely detached at the base.

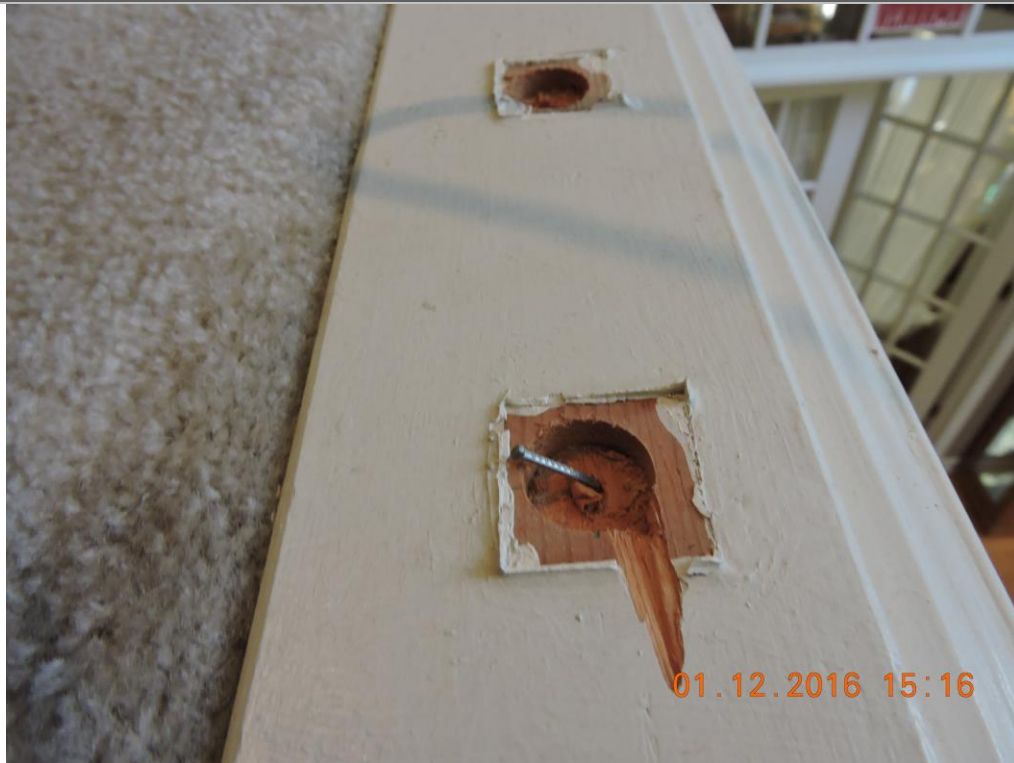
PHOTO 25

Each individual baluster completely detached at the base.

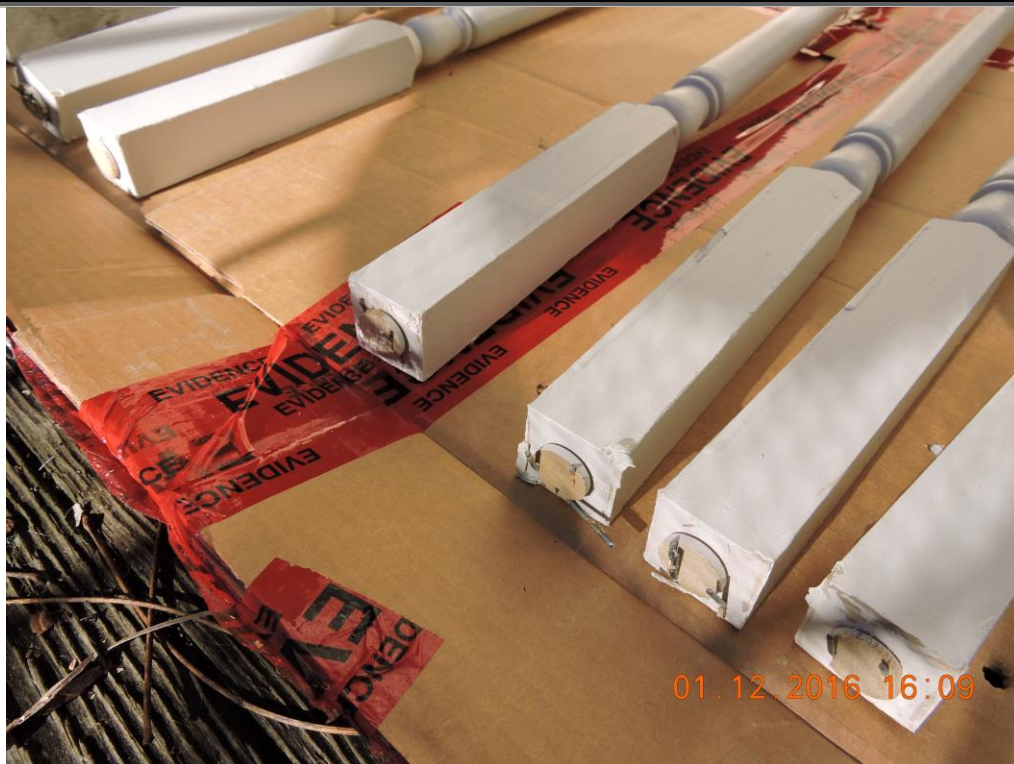
PHOTO 26

Each individual baluster completely detached at the base.

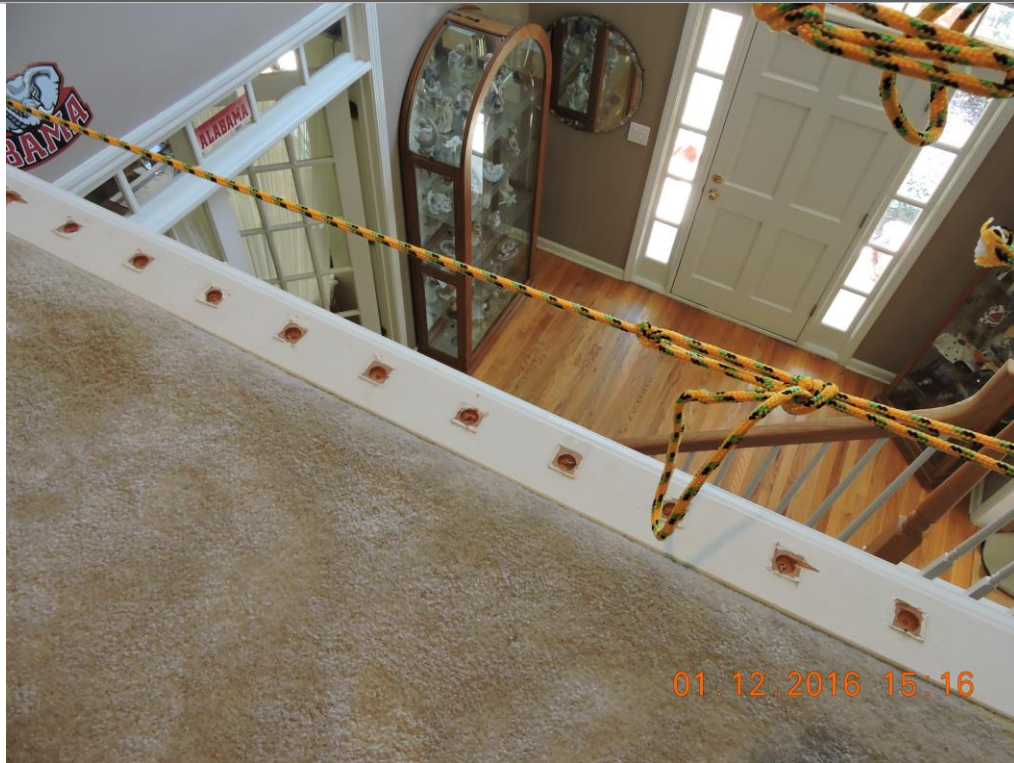
PHOTO 27

The horizontal baseplate remained in place.
