Reference: Property Inspection Report

Replacement Cost Estimate

Row House - End

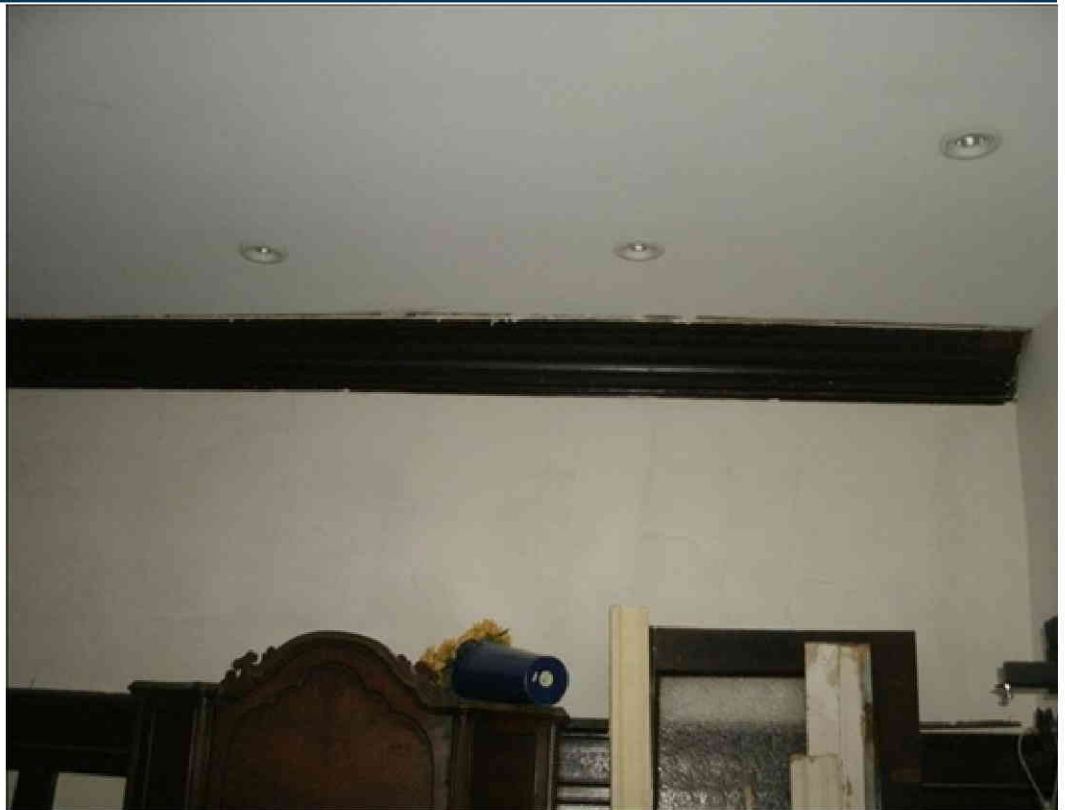
- **Renovation/Construction: Initial not Complete**

Crown Molding seperating from the ceiling.

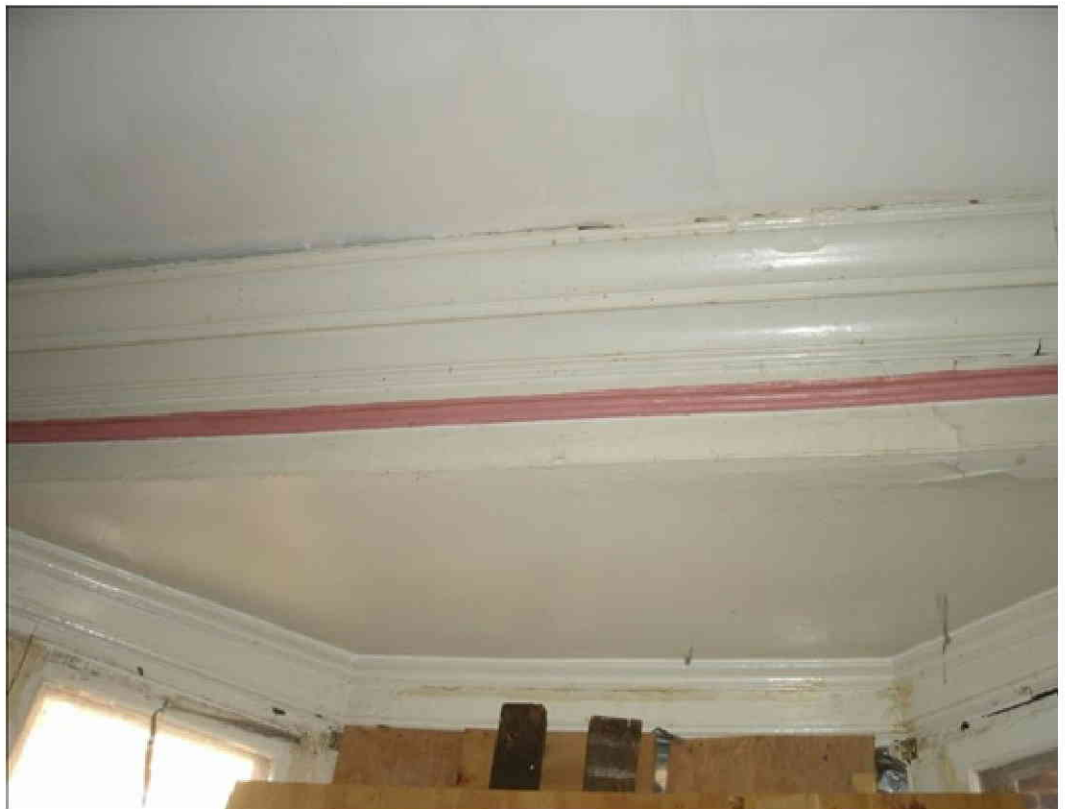
- **Renovation/Construction: Under Renovation**

Crown Molding

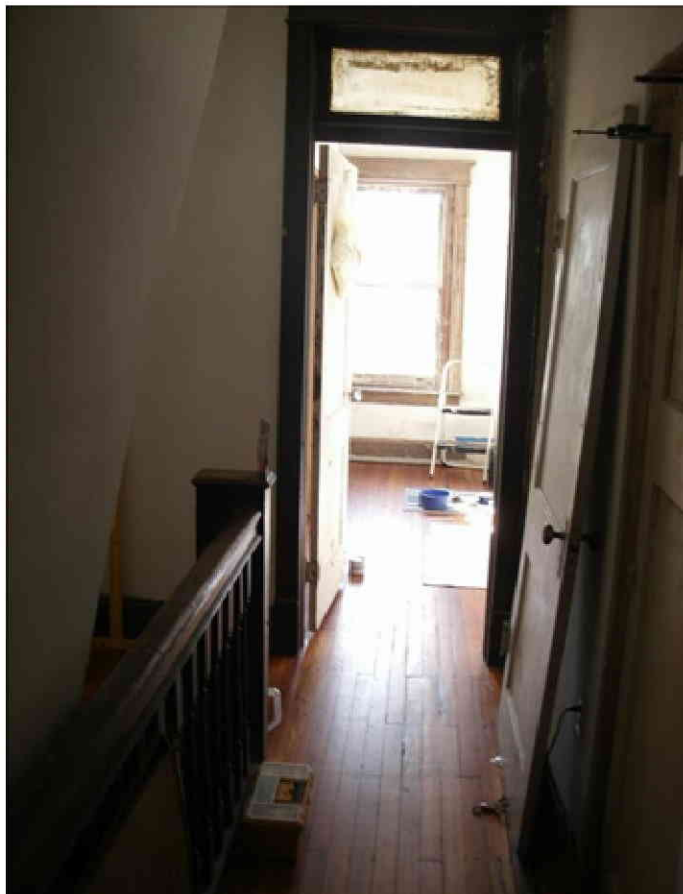
- **Renovation/Construction:**
Under Renovation

Detached doors in the second floor hallway

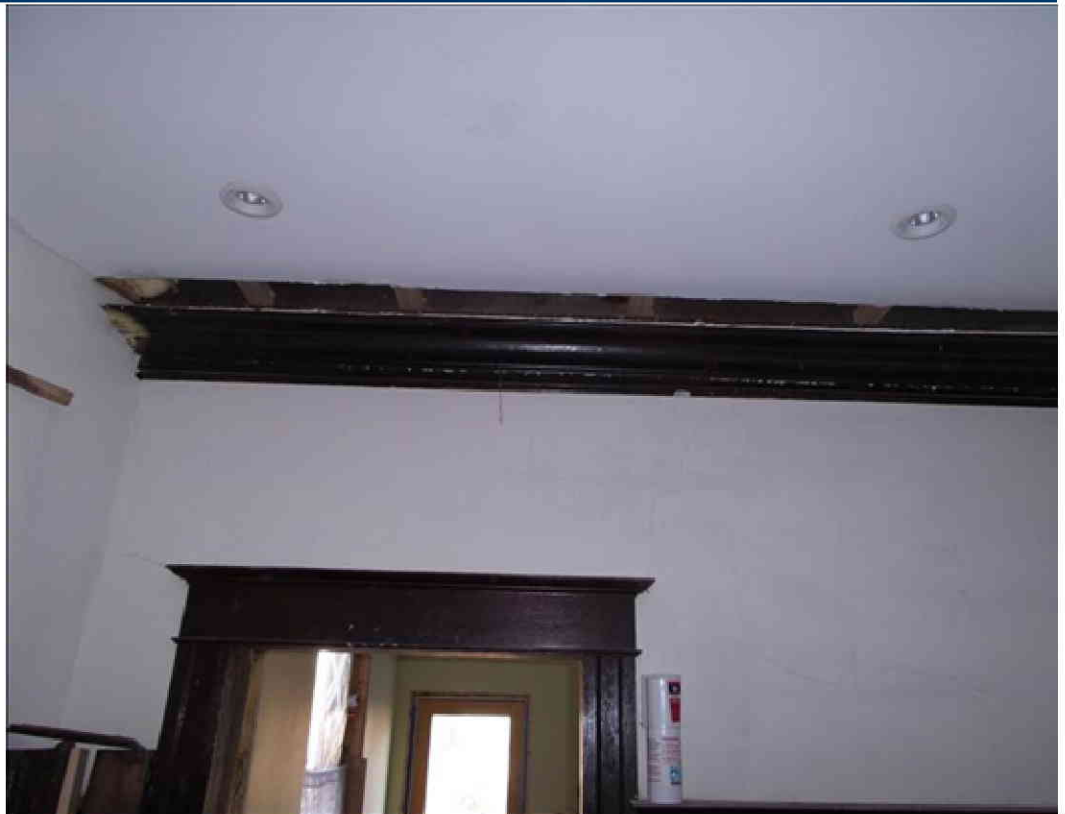
- **Renovation/Construction:**
Under Renovation

Crown molding seperating from ceiling

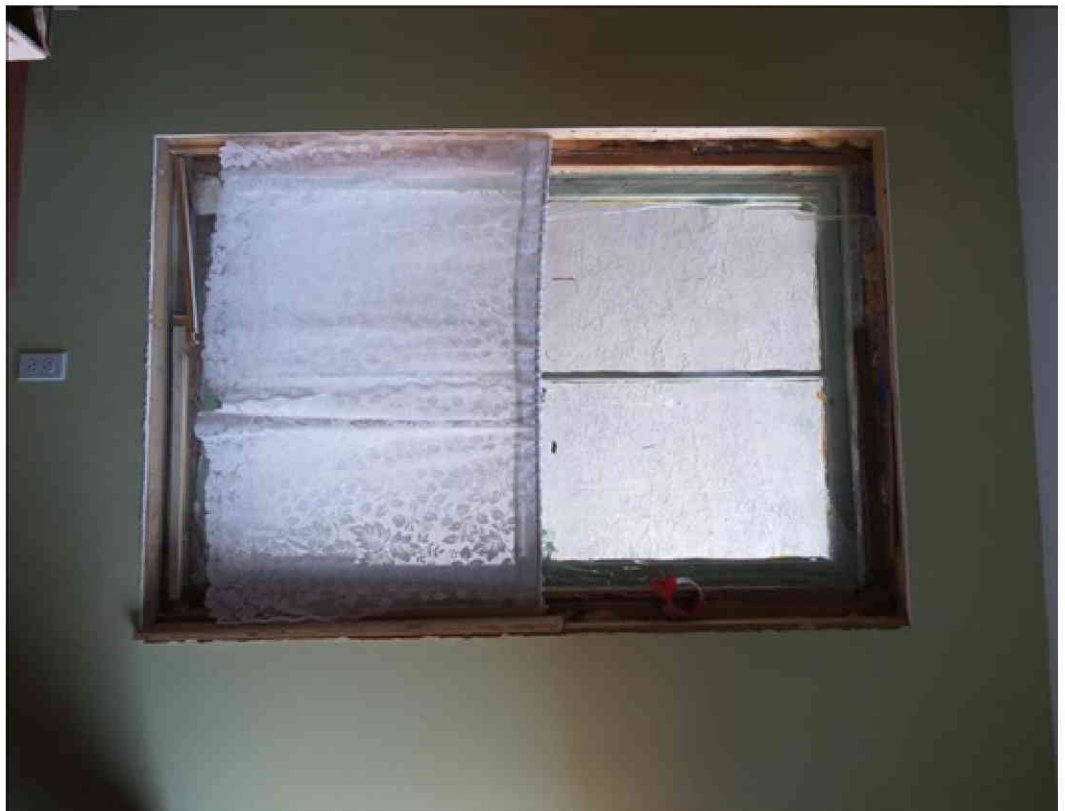
- **Renovation/Construction:**
Under Renovation

wood trim missing from window

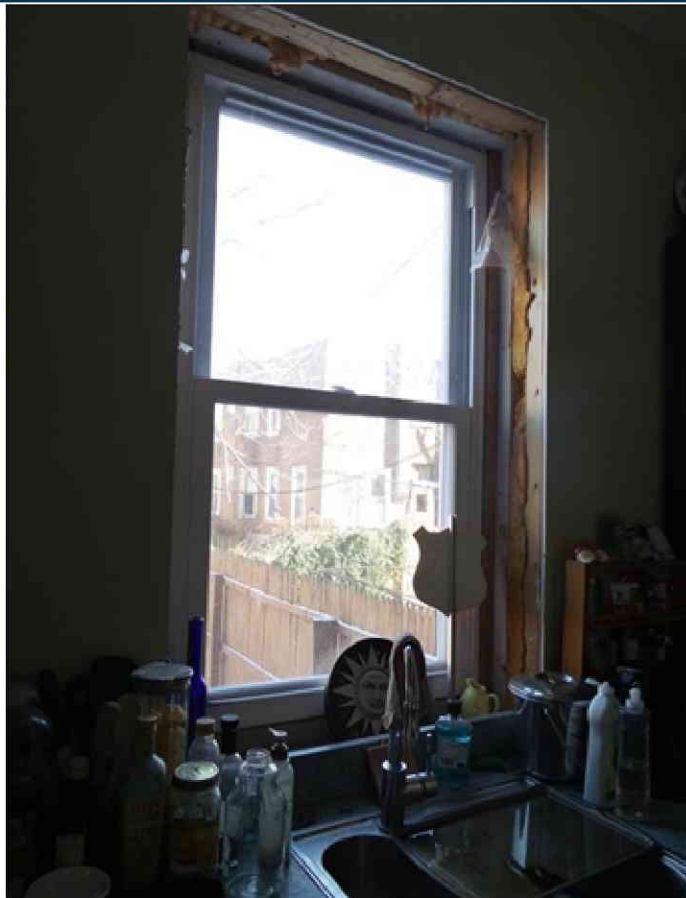
- **Renovation/Construction:**
Under Renovation

wood trim missing from window

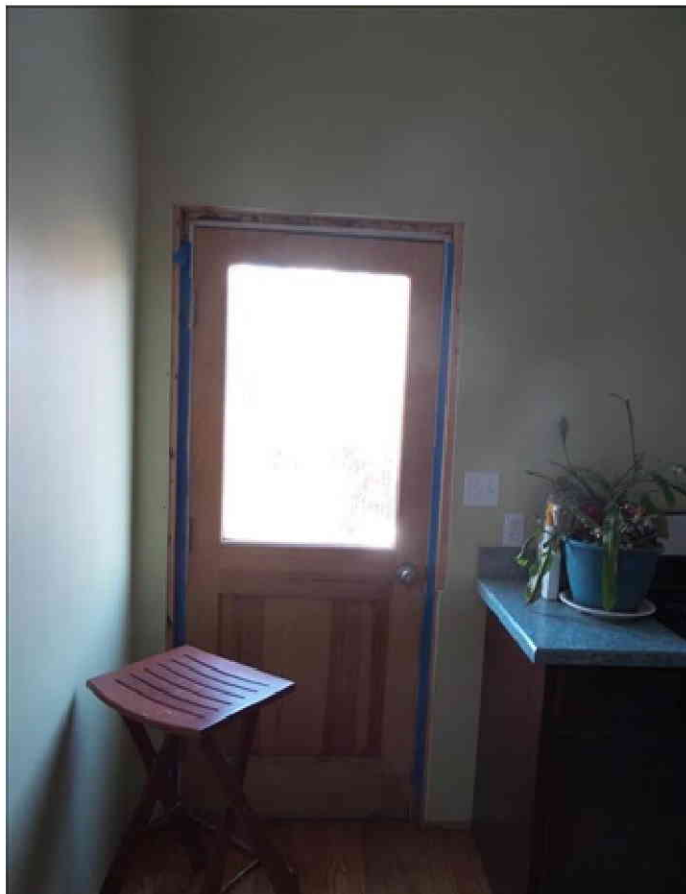
- **Renovation/Construction:**
Under Renovation

wood trim missing from door

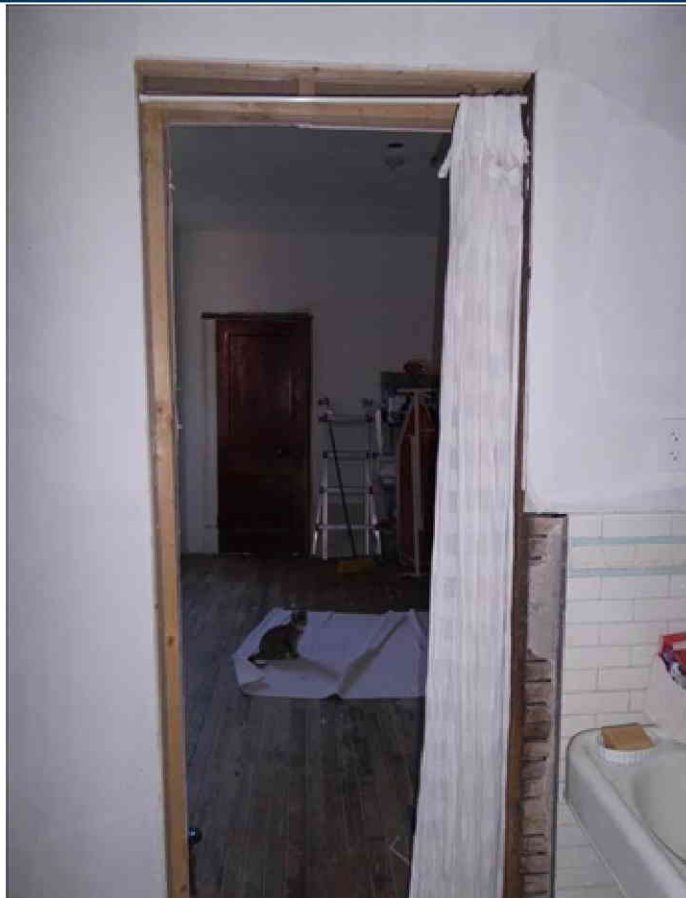
- **Renovation/Construction:**
Under Renovation

wood trim missing from door

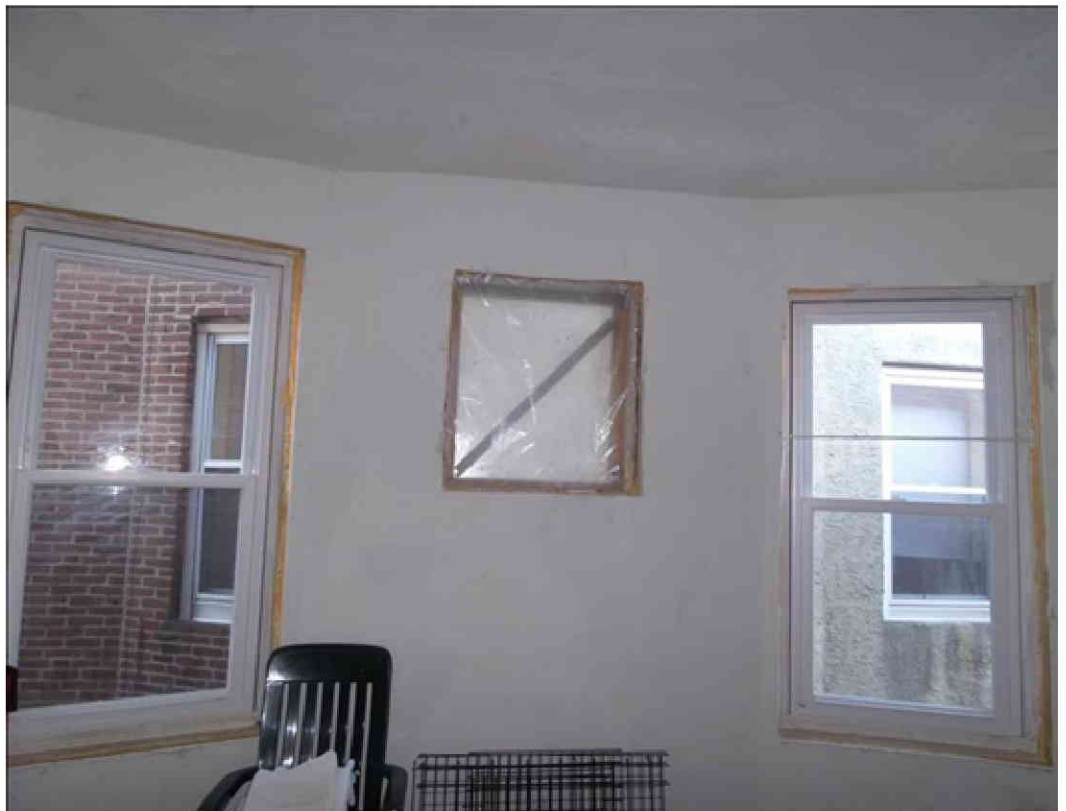
- **Renovation/Construction:**
Under Renovation

wood trim missing from window

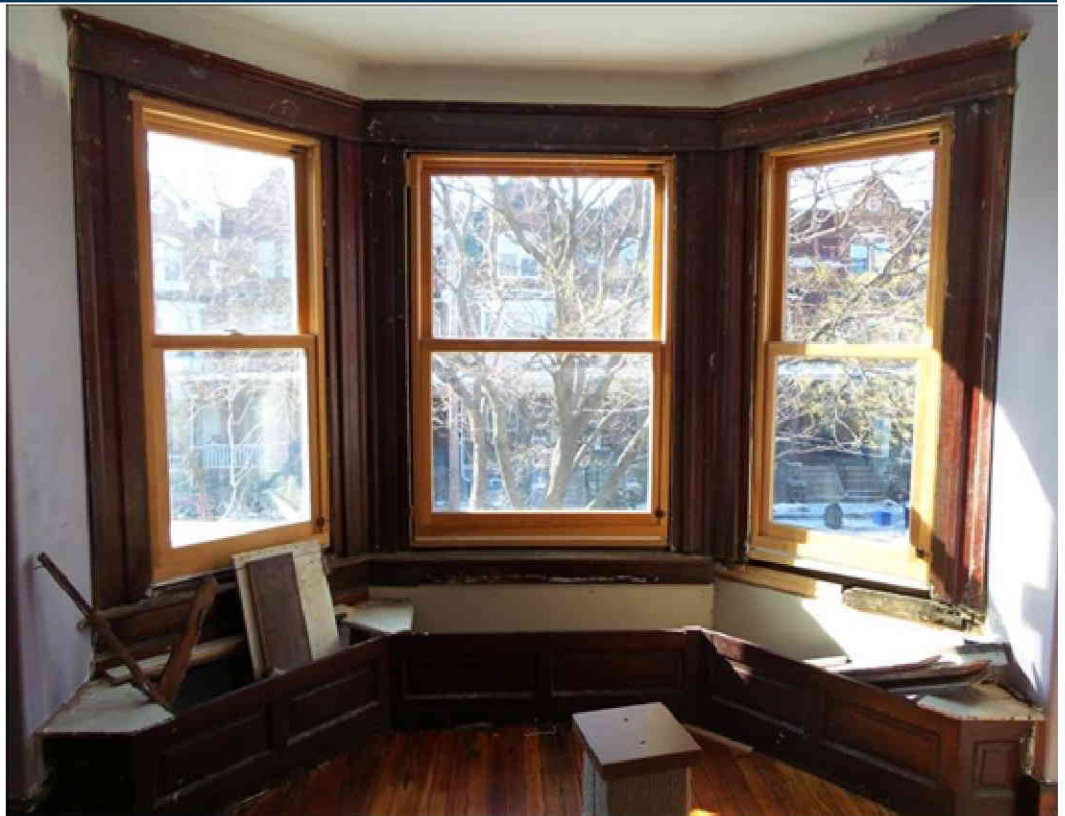
- **Renovation/Construction:**
Other

unfinished floor cabinets

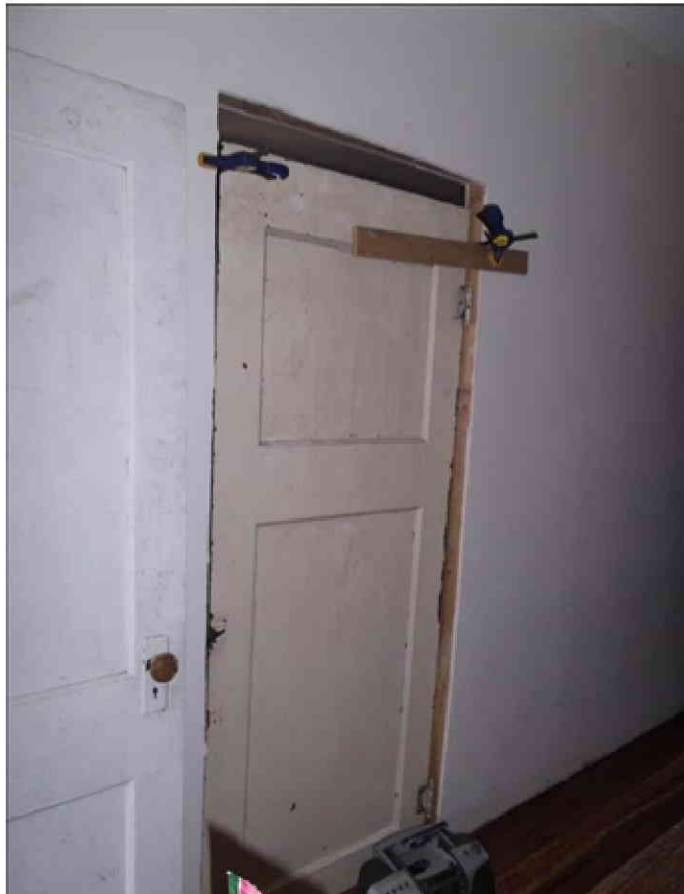
- **Renovation/Construction:**
Under Renovation

Temporary doors

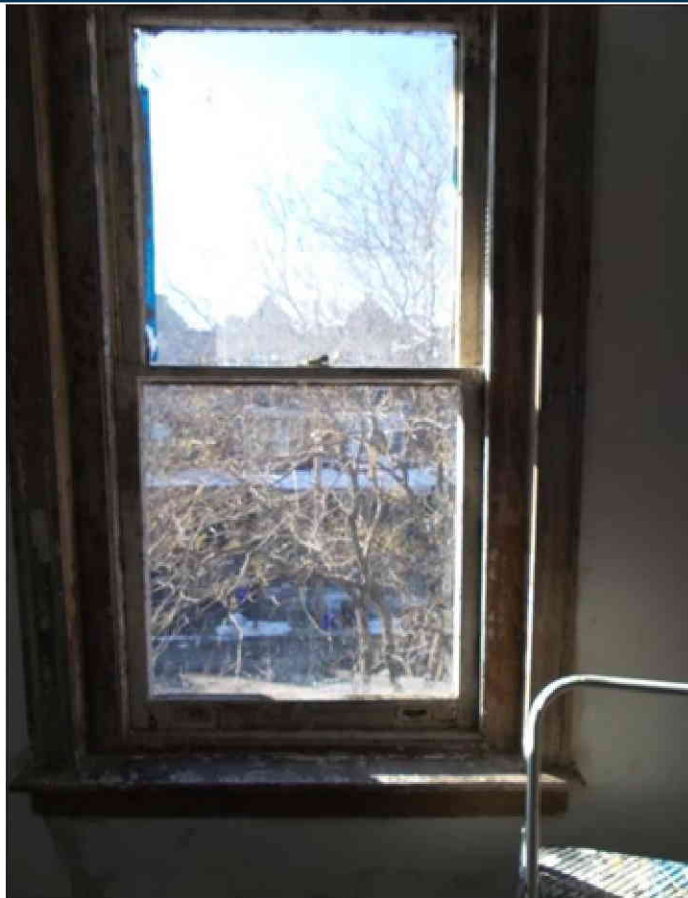
- **Renovation/Construction:
Under Renovation**

unpainted windows

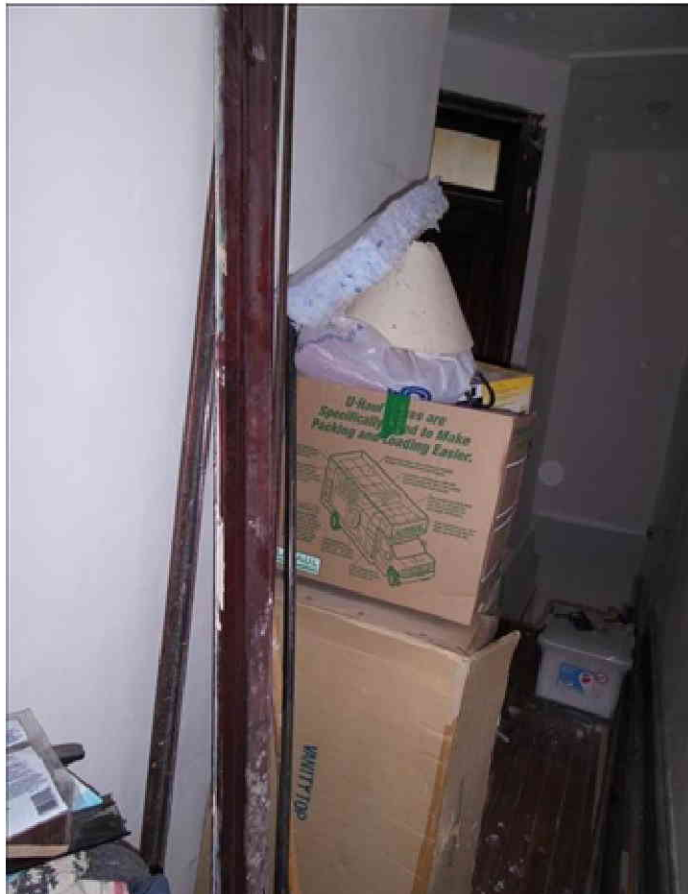
- **Renovation/Construction:
Under Renovation**

replacement Wood frames for doors

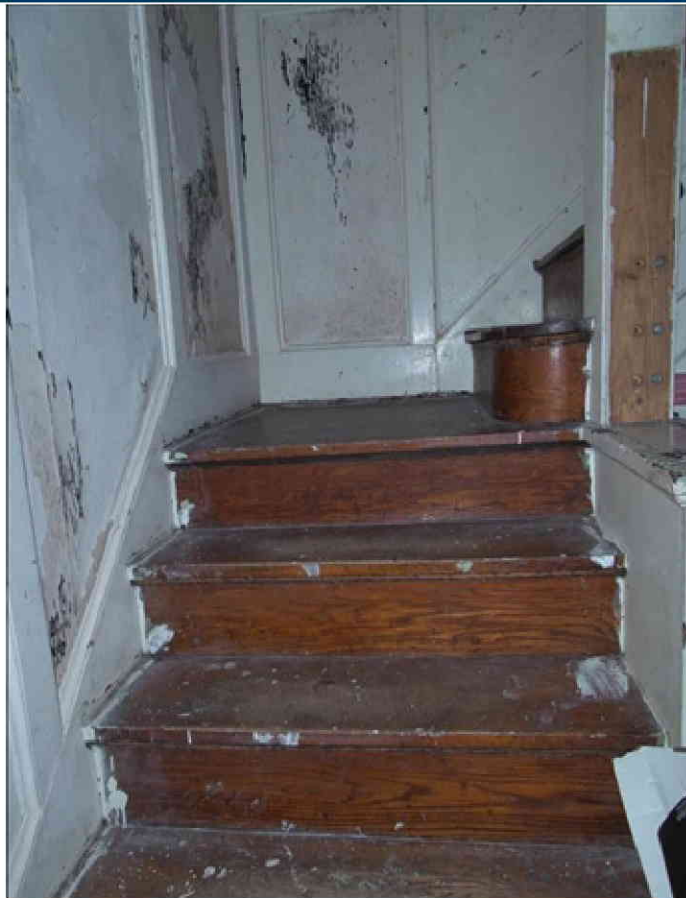
- **Renovation/Construction:**
Under Renovation

Scraped walls awaiting paint
